# GRAVELY *Technical* BULLETIN

BULLETIN NO. 966  
DATE: June 11, 1962  
TO: ALL OUTLETS

- SUBJECTS:
1. Horsepower loss on tractors equipped with Gravelly double air-guard cleaner.
  2. New main drive casting for 50-inch rotary mower.
  3. Modified exhaust valve plunger guide and cover.
  4. Sprayer gun-jet stem cracking.
  5. Change in width of Parker lawn sweeper.

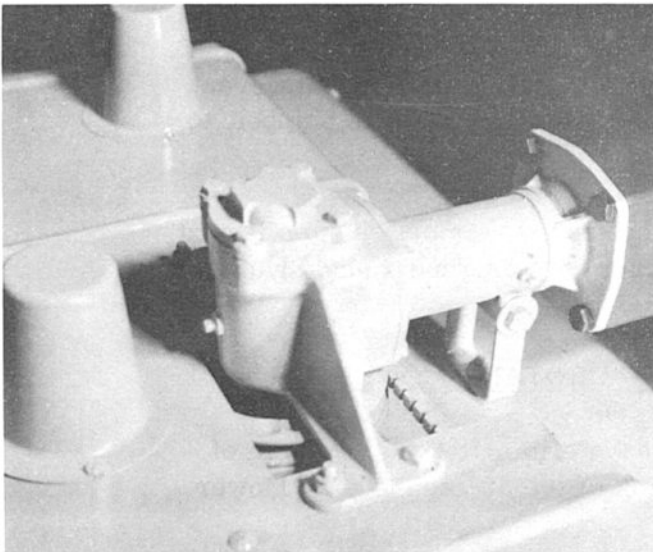
Two important production changes have eliminated the problem of cracking of the ribs on the Main Drive Casting of the 50-inch Rotary Mower.

First as shown by 1 in Figure 2, the ribs of the Main Drive Casting, part number 6501, have been made stronger. For comparison, see the original Main Drive Casting in Figure 1.
