## ILLUSTRATED PARTS LIST

PTO REAR (816)

Model Number Effective Date Form Number 19134E1 12-1-74 20935L1

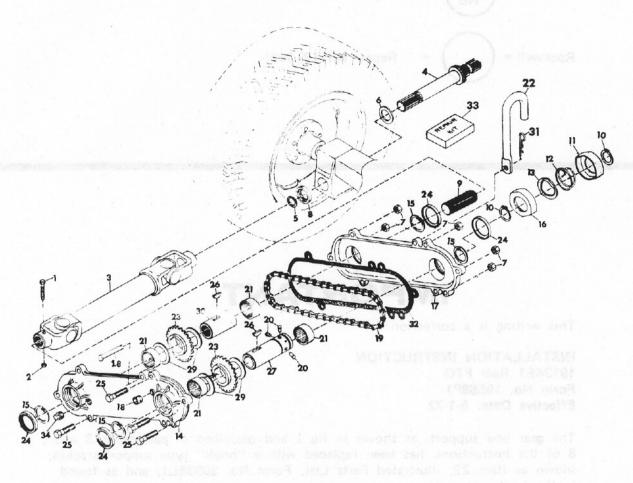
ITEM NO.	PART NO.	DESCRIPTION	
1	180044	Bolt, Hex 1/4-20 x 2	
2	9419454	Nut, Lock 1/4-20 Wash	her Insert Hex
3	18971P1	Shaft, Drive (Rear)	
4	18978P1	Shaft	
5	14987P1	Ring, Retaining Eator	n 329-1
6	17959P1	Bearing, Thrust Race	
7	456004	Nut, Lock 3/8-16 Wash	her Insert Hex
8	19537P1	Bearing, Thrust Race	
9	18972P1	Shaft	
10	18962P1	Ring, Retaining	
11	18967P1	Retainer, Outer	
12	18965P1	Spring	
13	18966P1	Cam	
14	18949P1	Housing, Front	
15	18960P1	Ring, Retaining	
16	18963P1	Retainer, Inner	
17	18948P1	Housing, Rear	
18	18968P1	Plug, Vented	
19	18957P1	Chain, Roller	
20	18964P1	Pin	
21	18950P1	Bearing, Needle 1-1/	2 x 1-7/8 x 1/2
22	20821P1	Bracket, Rear P.T.O.	
23	18953P1	Sprocket	
24	18961P1	Seal, Oil 1-1/2 x 2-1/8 x 5/16	
25	180130	Bolt, Hex 3/8-16 x 2	
26	431787	Key, Woodruff 3/16 x 5/8 Hard No. 61	
27	18952P1	Shaft	
28	9411602	Pin, Clevis 3/8 x 1.	875
29	18954P1	Bearing, Thrust Race	
30	18956P1	Shaft	
31	11860P1	Pin, Hair Cotter

32	18958P1	Gasket	
¥33	12134P1	Kit. Repair Universa	l Joint Rockwell Std.
*	20573P1		l Joint Neapco 1605X

\*NOTE: Brand of universal joint is identified by the end of the bearing cup.

The gear box support, as shown in fig 1 and described in paragraphs 3 and 8 of the instructions, has been replaced with a "hook" type support-bracket; shown as Item 22, Illustrated Parts List, Form No. 20935L1, and as found in the hardware pack.

3. Hook the support-bracket over the clutch cross-shaft of The Gravely. Position it between the spring-clamp assembly and the frame. Have the short end towards the rear as shown by the Illustrated Parts List.

Disregard paragraph 8. The "hook" must be removed when the gear box is removed after use.
